FEIAP Engineer of the Year Award 2008

CITATION FOR ENGR. DR. MOH ZA CHIEH

FEIAP Engineer of the Year Award
Nomination Form 2008

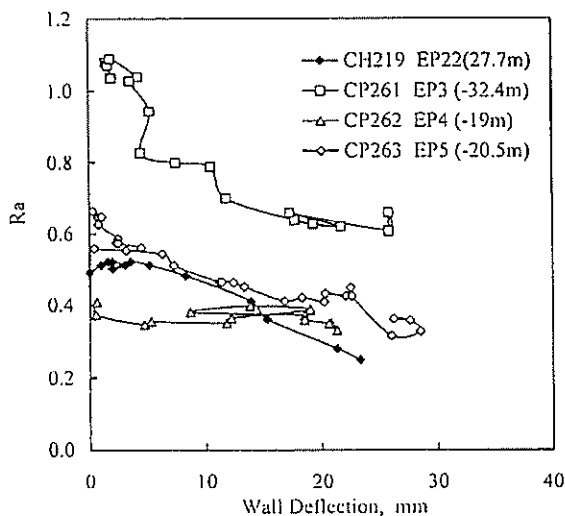
Fig. 13 Earthpressure measurements for TRTS

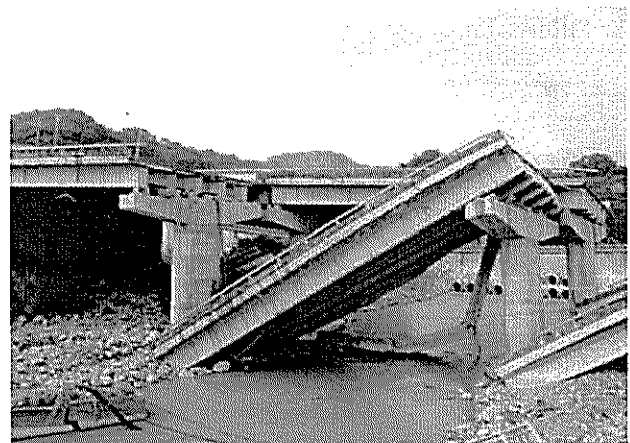
Photo 1. Bridge with Falling Spans

There are approximately 1,000 bridges in the areas with strong shaking and 20% of them suffered damages to certain degrees. Twenty bridges were seriously damaged and required extensive repairs or had to be demolished and rebuilt. Many of them are located on Route 3 which is a major north-south highway running the length of Taiwan from Taipei in the north to Pingtung in the south. There are approximately 65 bridges on this route as it passes through Taichung and Nantou counties. Five of these bridges suffered collapsed spans (Photo 1) or cracked piers (Photo 2). Another five bridges on county and city highways experienced similar distress, including one cable-stayed bridge under construction. All these ten bridges are within 10km of the fault and most are within 5 km. Seven are located directly on the causative fault or on one of its branches. All are considered to be in the near

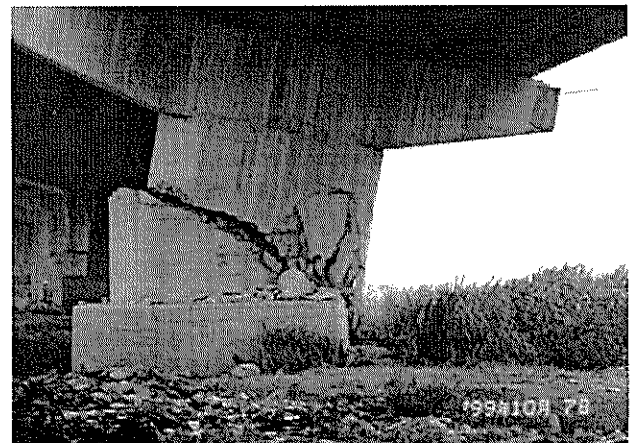
Photo 2. Bridge with Pier Damaged

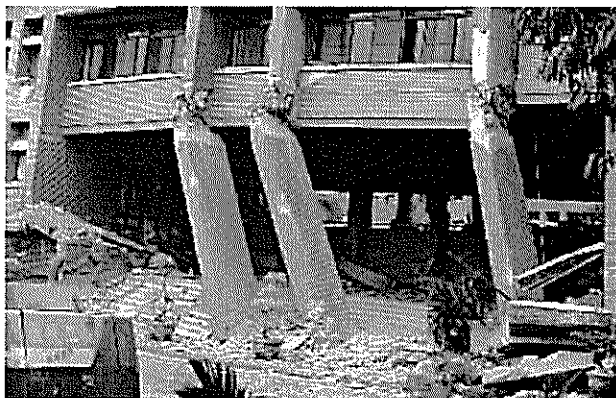
Photo 3. Building with Weak Ground Floor

A large percentage of buildings that collapsed were non-engineered one-to-three story reinforced concrete frame structures constructed with brick infill partitions and exterior walls. Many of them had pedestrian corridors and open front at the ground floor (Photo 3). More than two dozen modern high-rise apartment buildings overturned or collapsed (Photo 4) because of inadequate design. Some of the buildings collapsed because of the so-called "short-column effects" as the spaces between columns were partly filled by partition walls (Photo 5). These partition walls trap the columns preventing the development of their normal flexural behavior over their height and allowing them to only deform over their free-height, i.e., the length of the column not surrounded by partitions. As a result, although the shorter length of the trapped column would make it possible to resist higher lateral forces before the flexural strength of the column is reached, the shear strength of a short column is often first reached and typical non-ductile shear failures ensue.

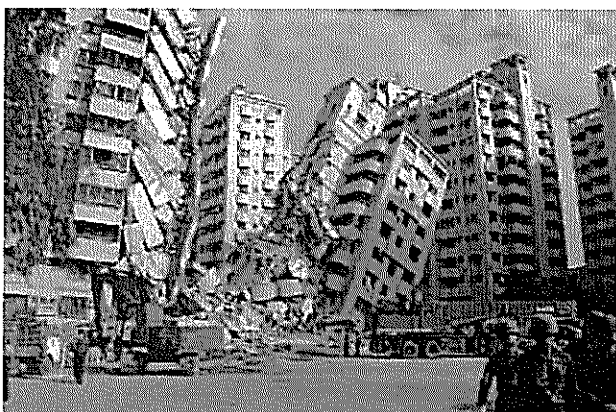
Photo 4. Poorly Designed Modern Highrise Buildings

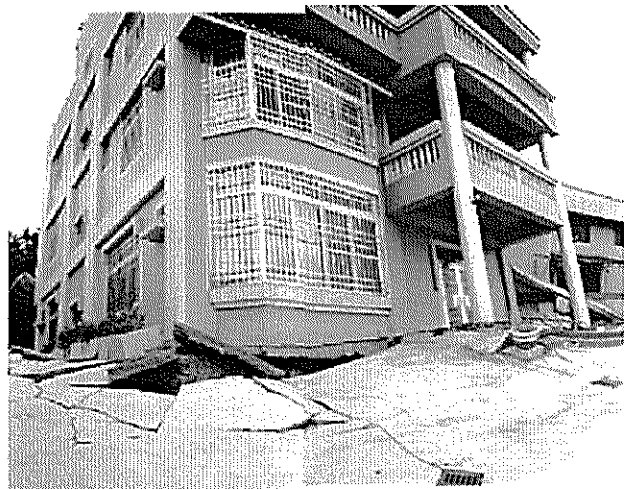
Photo 6. Building Damaged by Ground Movements

One of the significant features of the Chi-Chi earthquake was its large lateral and vertical displacements at surface. Buildings constructed across faults typically cannot survive the relative displacements that occur at their foundation due to fault movements. This type of failure was commonly seen along the fault (Photo 6).

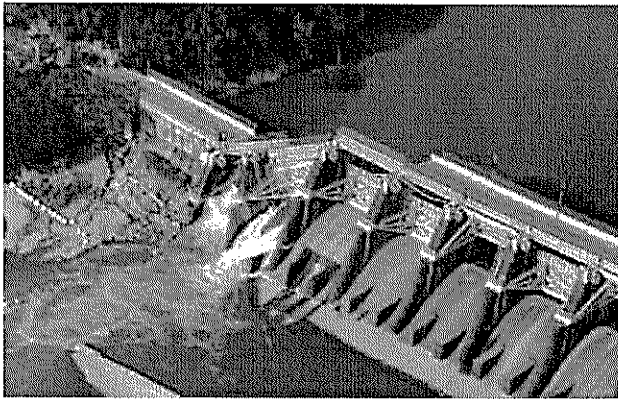
Photo 7. Shikung Dam after Earthquake

Damages to hydraulic structures were rather light. Of special interest is the Shikung Dam which is a concrete dam and was seriously damaged by ground movements (Photo 7). The fault directly ran through the foundation of the dam. The eastern portion of the dam was jacked up by 9.8m and the western portion of the dam was jacked up by only 2.1m, resulting in a differential movement of 7.7m.

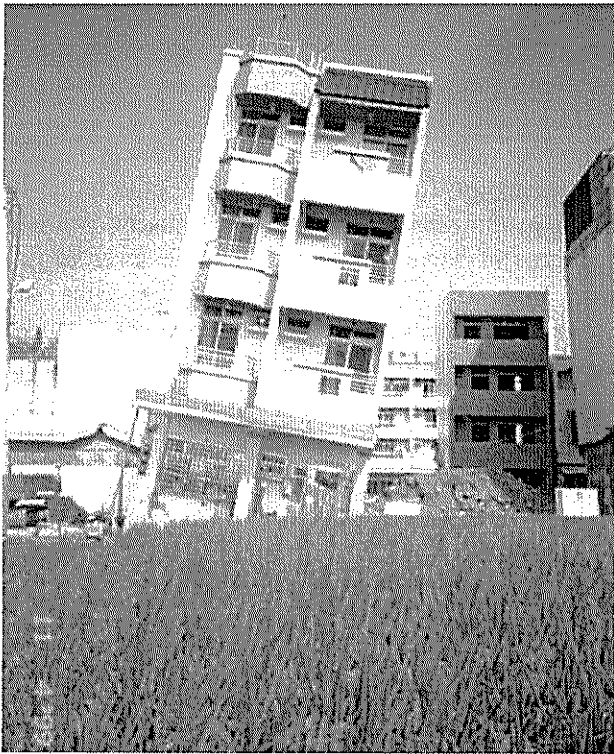
Photo 8. Foundation Failure Due to Liquefaction

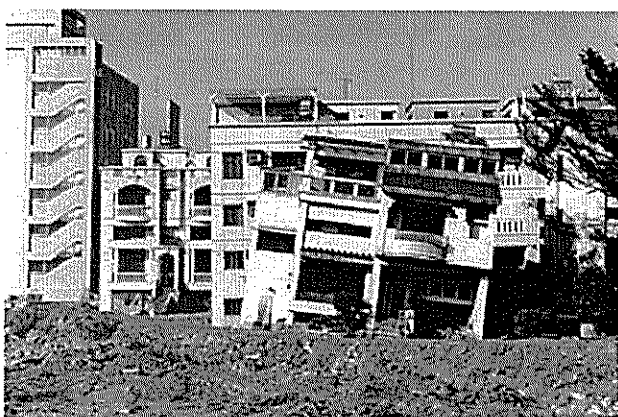
Photo 9. Building Damaged by Lateral Spreading

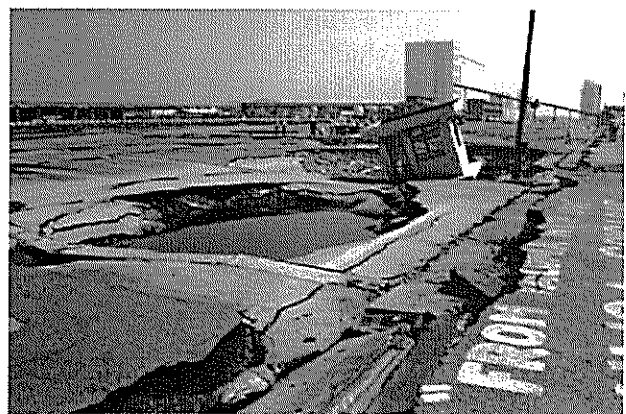
Photo 10. Damage to Taichung Port Due to Liquefaction

Liquefaction at Taichung Port, which is located about 55 km northwest of the epicenter, damaged 4 of its 45 docking wharves. The port was built on a

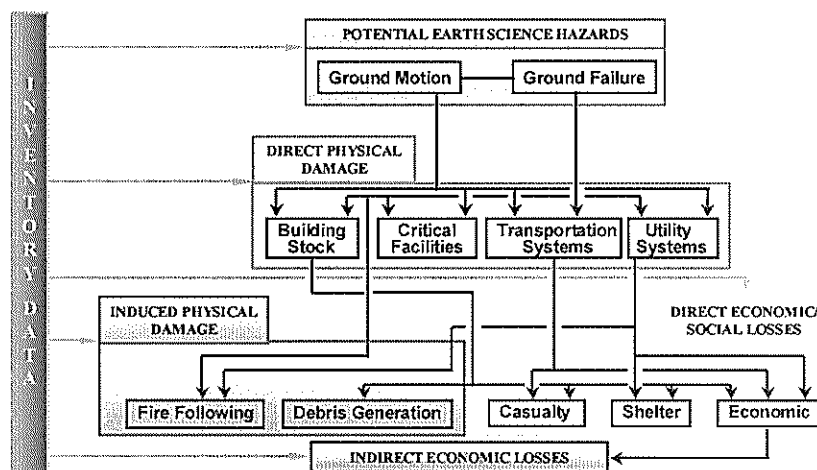
Figure 20. Structure of HAZ-Taiwan/TELES.

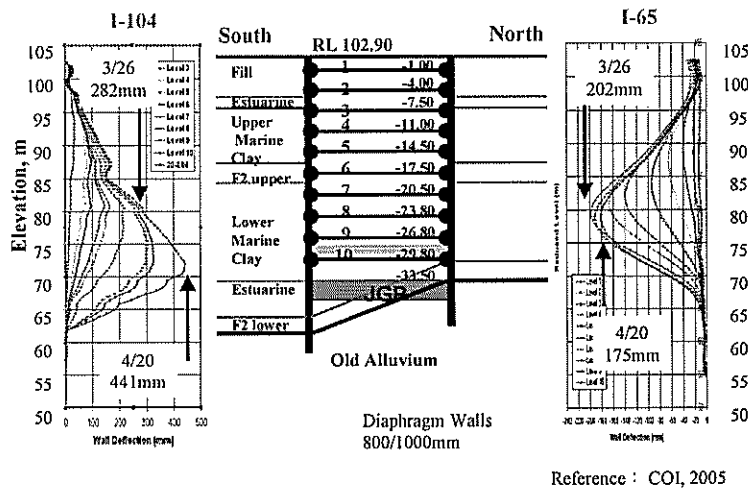
Fig. 2 Ground conditions and retaining system at the MRT site next to Nicoll Highway, Singapore
